## **SUBJECT: C310 Boom Mount**

(Relates to Boom used with Standard Sails without In-Mast Furling)

(Posted 8/11/2003 on the Sailnet C310 Discussion List)

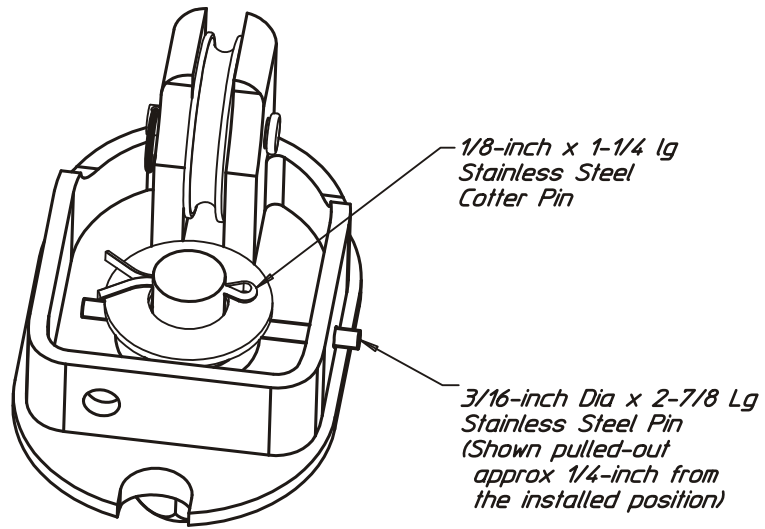
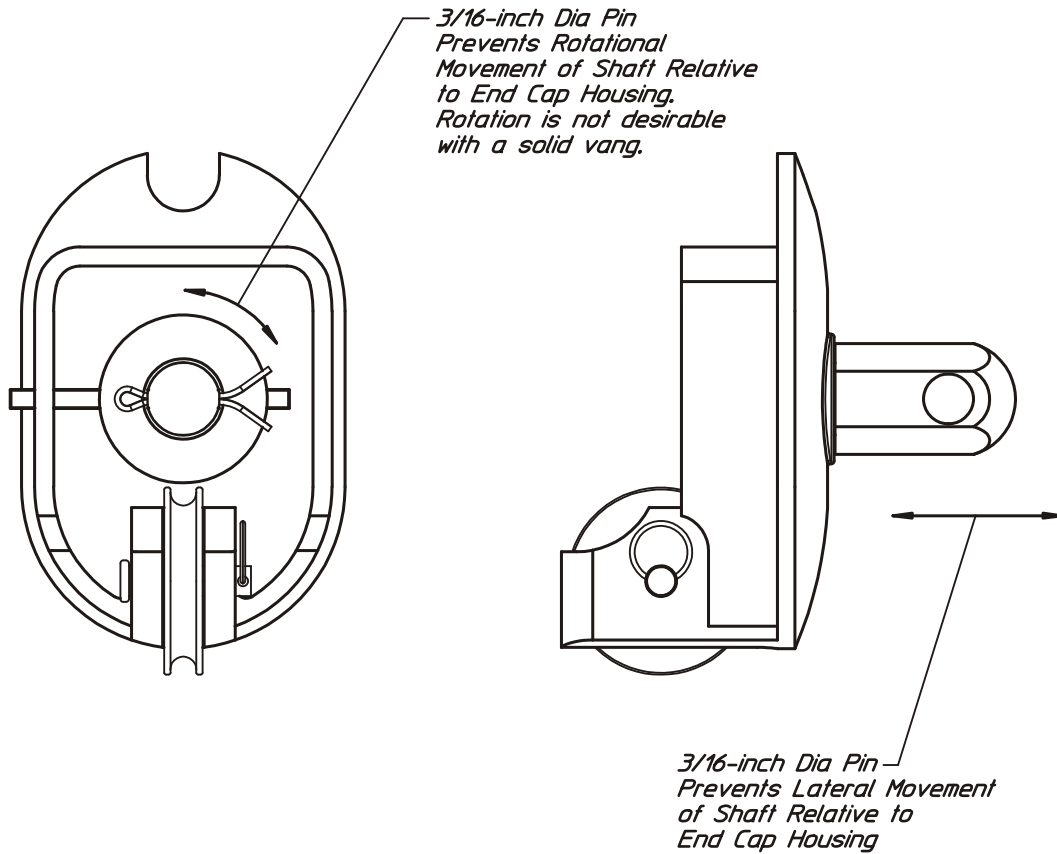
*C310 BOOM END CAP ASSEMBLY*

Back in June (2003) there was some discussion on this List regarding the boom mount. Apparently several C310 owners have noticed issues where the gooseneck shaft mounts to the boom forward end cap. From those messages I took a close look at mine, I suspected mine had the problem and so I contacted my dealer. A positive indication that something isn't quite right is if the boom forward end cap can rotate on the shaft it is mounted to, or has excessive fore-aft end play. There was also an annoying squeak from this area when sailing in light winds.

There were several comments on this discussion List about the size of the cotter pin (visible through the boom where the reefing line exits, forward port) and about the number and size of washers that go on just before the cotter pin. I even speculated that a clevis pin would be desirable in place of the small cotter pin. Well, it turns out that there is an easy fix. If yours is like mine, it is simply a case of a missing pin and perhaps an undersized cotter pin. There is supposed to be a 3/16-inch-dia x 2-7/8-inch long stainless steel pin that engages the boom end cap and the gooseneck shaft. This pin positively prevents fore-aft movement and also prevents the boom from rotating about its centerline axis (which isn't desirable with a solid vang as the C310 has). Additionally, there is a heavy flat washer and then an 1/8-inch-dia cotter pin as an additional measure.

My dealer and the factory were very helpful in resolving this issue and I'd bet they'd be helpful to others with this same issue. I installed the parts myself and it was easy and took about 15 minutes (30 if you count the time to get your buddy a beer), but requires two sets of hands. You basically loosen the outhaul line and disconnect the front of the boom from the mast (no need to remove the sail as the solid vang and topping lift tend to balance things by themselves). You then remove the four screws that hold the end cap and tap off the end cap (each side a little at a time) being careful not to drop it on the deck or hatch below it. If the cotter pin isn't 1/8-inch dia, then replace it. Then slide the 3/16-inch pin through the end cap and through the shaft. I coated all stainless steel-to-aluminum interfaces with anti-sieze compound for future ease of dis-assembly. Then tap the end cap back on, re-install the four screws and re-secure the boom to the mast. You may need an extra set of hands for this part and I found it helpful to adjust the vang line tension to aid in getting things to line up. Re-tighten the outhaul and that's it-all fixed. I have created an illustration that shows what the inside of this assembly looks like (see page 2 of this .pdf file).
